Washington State
School Seismic Safety Assessments Project

BURLINGTON-EDISON HIGH SCHOOL GYM/FIELDHOUSE BUILDING

SEISMIC UPGRADES CONCEPT DESIGN REPORT

June 2021

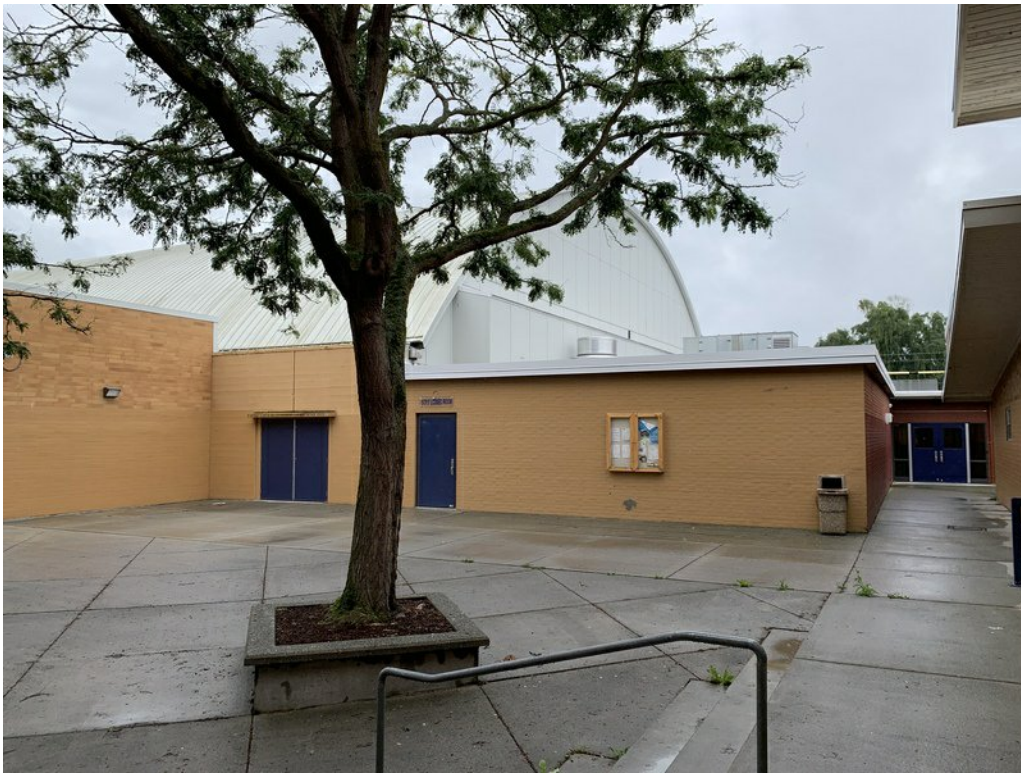
Figure 1-1. Fieldhouse, Northwest Corner

Structural Floor(s)	No visible deterioration or damage was observed.
Foundations	No visible deterioration or damage was observed. The below-grade foundations were not visible.
Gravity System	No visible deterioration or damage was observed.
Lateral System	No visible deterioration or damage was observed.

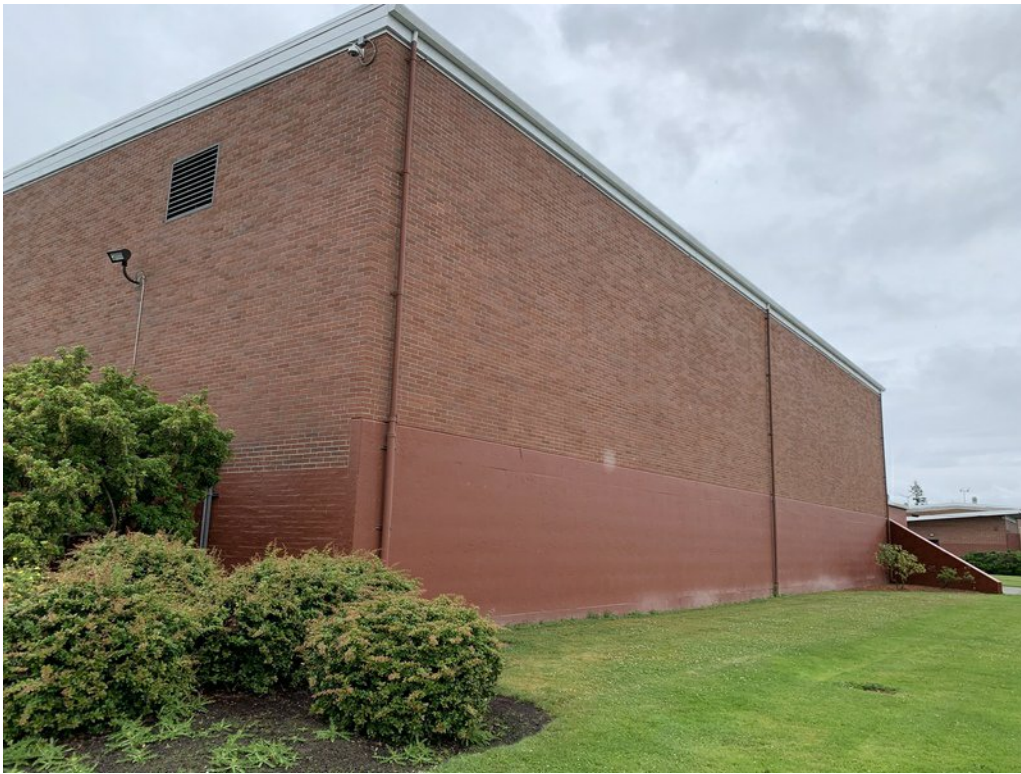
Figure 1-1. Building Southeast Exterior.

Structural System	Description
Structural Roof	No visible deterioration or damage was observed.
Structural Floor(s)	No visible deterioration or damage was observed.
Foundations	No visible deterioration or damage was observed. The below-grade foundations were not visible.
Gravity System	No visible deterioration or damage was observed.
Lateral System	No visible deterioration or damage was observed.

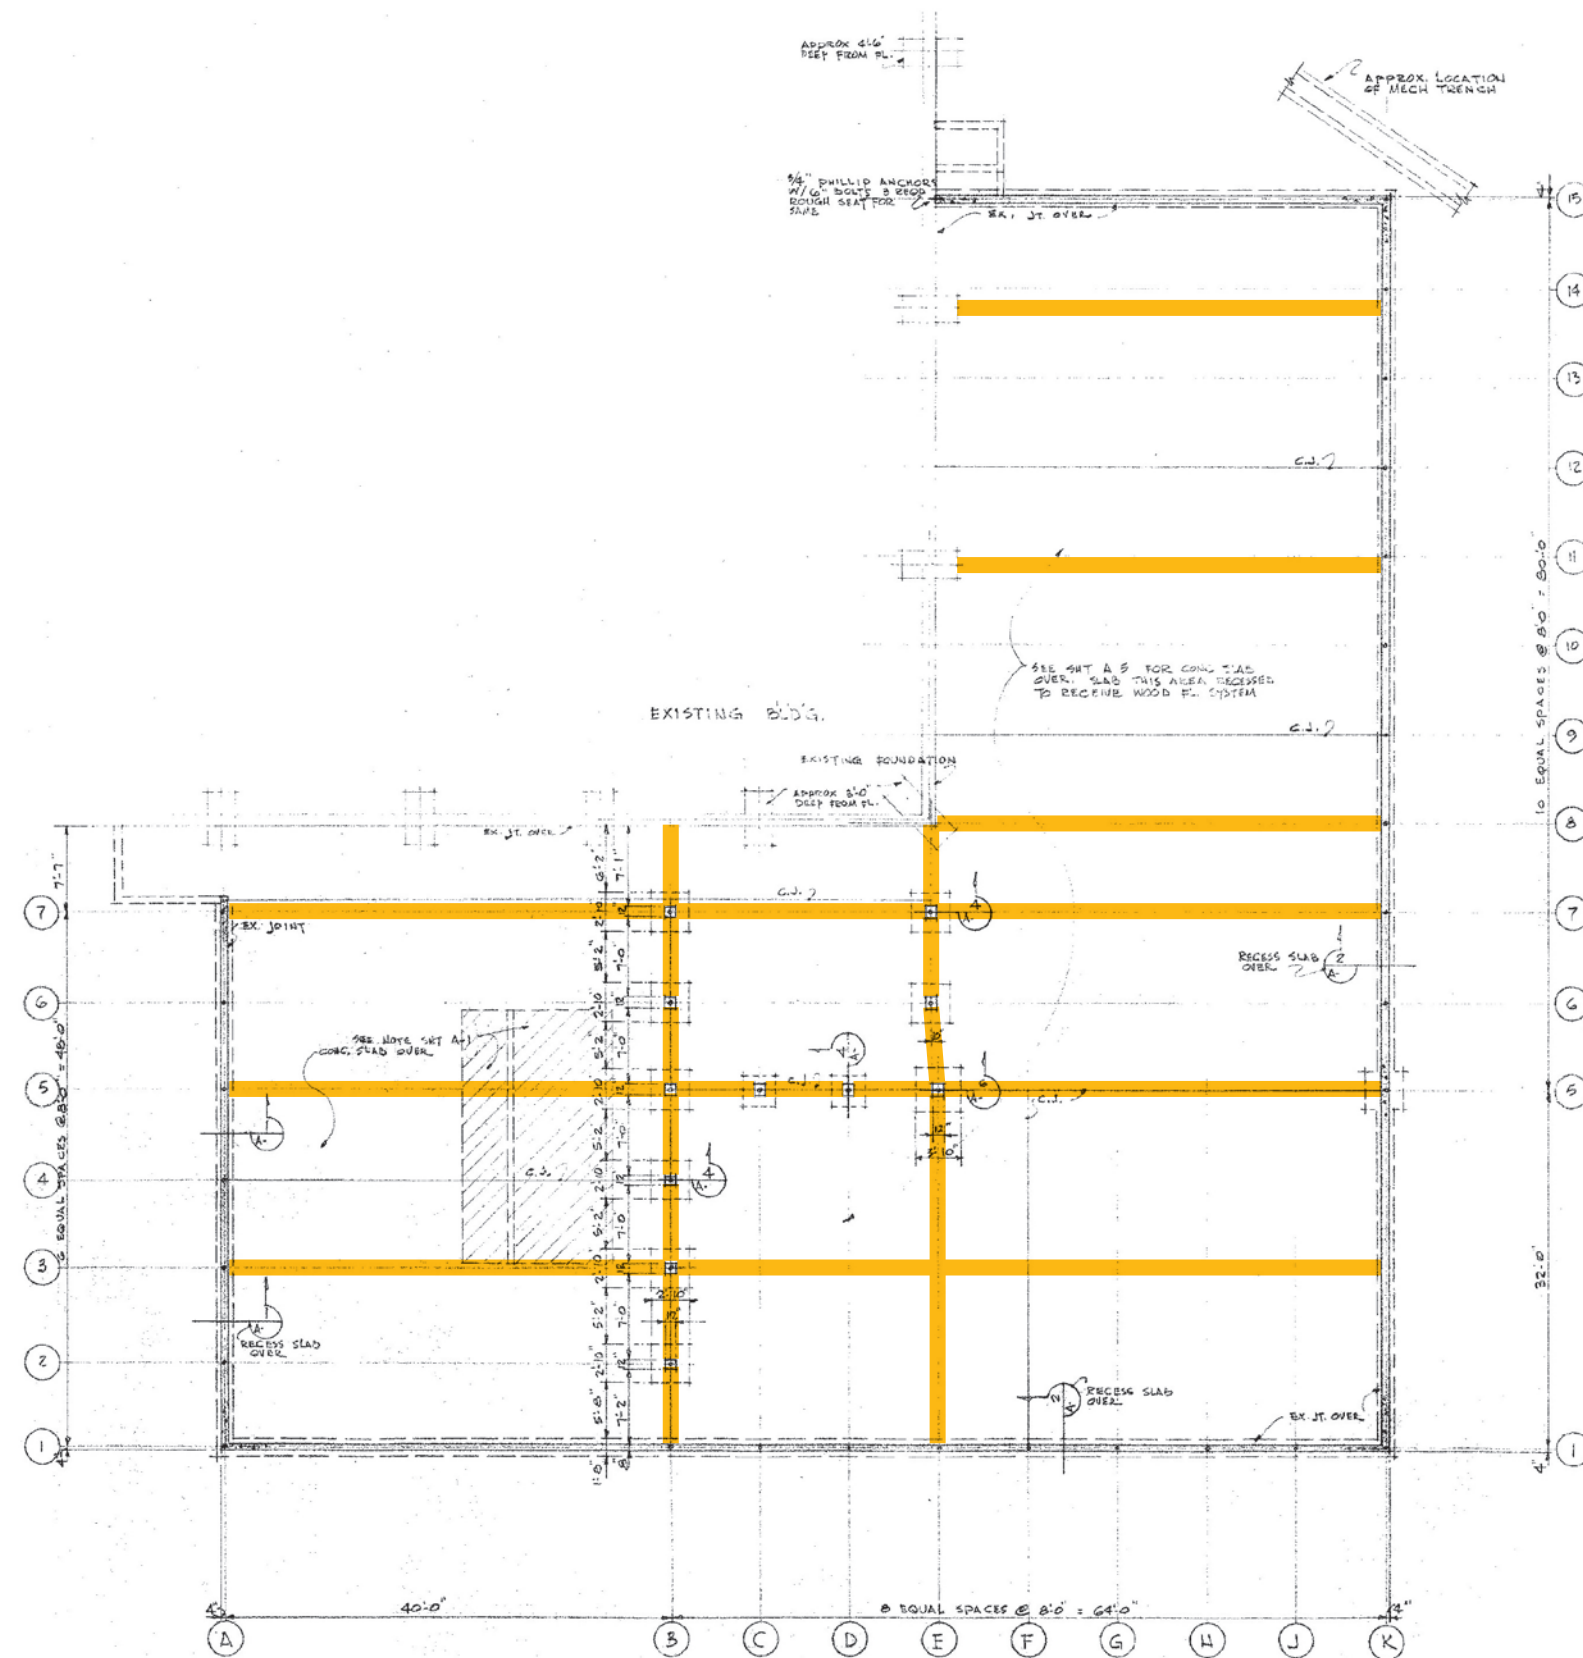
Deficiency	Description
Ties Between Foundation Elements	There are ties between the foundation elements in the 1953 gym; however, in the remaining structure, there are no ties across the building or slab ties indicated in the record drawings. Soils and liquefaction review should be performed to verify capacity of exterior soils to restrain wall movement. Additional foundation ties may be appropriate to mitigate seismic risk.
Spans	The diaphragm for the 1950s portion of the structure has diagonal 1x sheathing and is compliant. However, the 1970s portion of the structure has straight sheathing diaphragm and spans larger than 24 feet. The 1970s portion of the structure is noncompliant with this checklist item. Strengthening of the roof diaphragm may be warranted to increase the building seismic strength.
Cross Ties	The 1950s portion of the building and the 1970s portion of the building do not have continuous cross ties in both direction. The addition of cross ties may be warranted to improve building seismic performance.

Add Concrete Foundation Cross Tie Grade beams
